# Cross Generating Station Bottom Ash Pond

## Periodic (5-Yr) Structural Stability Assessment

Document No.: CROSS-0-LI-044-0017 - Rev 1

07 Nov 2021

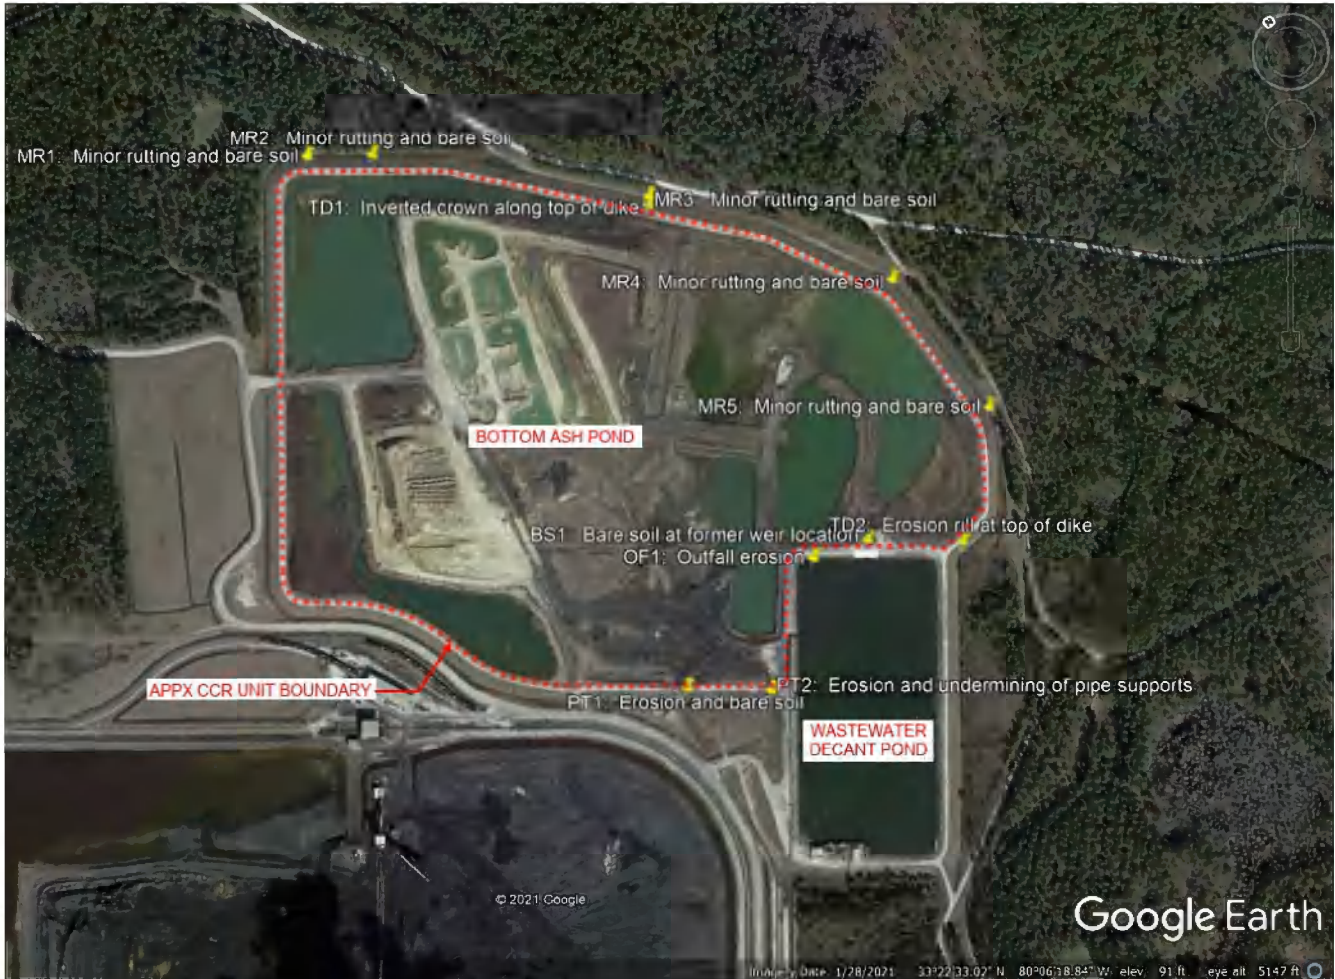
**BA Pond Observation Location Plan [Ref. Google Earth]**

- 1. Observations MR1 through MR5:** There are five areas along the outer slope of the pond embankment where some very small areas of thin vegetation or bare soil, and minor rutting, was observed. These areas appear to be caused by rutting from tractor tires as a result of routine mowing operations. Two such areas (MR1 and MR2) are located near the northwest corner of the pond, west of monitoring well CAP 6. A third area (MR3) is located about 70 feet west of monitoring well CAP 7. A fourth area (MR4) is located about 80 feet east of monitoring well CAP 8. The fifth area (MR5) is located about 130 feet south of monitoring well CAP-9. Weekly monitoring of these areas should be continued, and the areas re-seeded if conditions worsen.

- 2. Observations TD1 and TD2:** The top surface of the dike in one area (TD1) near CAP 7 appears to exhibit a slight inverse crown that slopes to a low point along the outer edge of the dike that currently collects and concentrates more runoff than would otherwise be present from a well-distributed sheet flow off the dike alone. This low point is directly above the area of minor rutting observed near monitoring well CAP 7 (Observation MR3). The additional surface runoff in this area of the slope may be contributing to the conditions responsible for the minor rutting observed in this area of the slope. The top surface of the dike in another area (TD2) near the southeast corner of the BA Pond exhibits an erosion rill within the aggregate surfacing that is concentrating runoff over the outside edge of the dike.

- 3. Observation BS1:** A larger area of bare soil (BS1) was observed on the north slope (i.e. within the BA Pond) of the shared dike between the BA Pond and the WD Pond. This area is about 70 feet long measured at the top of the dike, extends down to the ash surface inside the BA Pond, and is associated with the work performed in 2020 to remove the former trapezoidal weir spillway that previously connected the two ponds hydraulically, prior to the initiation of closure by removal. This area did not appear to exhibit erosion at the time of the inspection, but the lack of fully-established vegetation on this slope may be susceptible to erosion in the future.

- 4. Observation OF1:** The temporary pump occasionally used to maintain the normal pool within the BA Pond was observed to sit on top of the dike between the BA Pond and the WD Pond, with the suction hose extending down into the BA Pond, and the discharge hose extending partially down the side slope into the WD Pond. At the time of the inspection, the water level in the WD Pond was lowered well below its normal pool to provide additional surge capacity in advance of wet weather. Some erosion of the WD Pond liner protective cover soil was observed around the hose discharge location. If left in its current configuration, this may result in further erosion of the protective cover soil, the underlying bentonite liner, and ultimately the downstream slope of the embankment.

- 5. Observations PT1 and PT2:** Erosion was observed in the vicinity of the cast-in-place concrete pipe trenches located along the southern embankment of the BA Pond, including the two westernmost pipe trenches

(PT1) and the eastern pipe trench (PT2). The erosion near the easternmost pipe trench has undermined at least one of the existing pipe support foundations located beyond the outside toe of the embankment, causing the pipes to separate from the supports. Existing grade along inside edge of the BA Pond dike near the pipe trenches is at or above the top surface of the dike, and local area stormwater runoff from the top of the dike is directed into or alongside the pipe trenches and allowed to concentrate as it runs off the exterior slope of the embankment, causing some erosion of the downstream slope of the embankment. While the ash pond embankment itself is intact, continued erosion in this area and additional undermining of the pipe supports could cause pipe failure and result in rapid erosion of the embankment and/or surrounding soils, or undermining of the pipe trenches themselves.

1. **Observations TD1 and TD2:** Limestone aggregate base course should be placed in these areas and the areas re-graded and compacted to re-establish the normal crown of the dike and restore well-distributed sheet flow conditions over the edge of the dike.

2. **Observation BS1:** The area of bare soil should be stabilized by permanently seeding the area as required to achieve a full stand of grass. The application of topsoil and erosion control blanket may be necessary to achieve final stabilization.

3. **Observation OF1:** The temporary pump effluent hose configuration should be modified to ensure non-erosive conditions at the hose discharge location.

4. **Observations PT1 and PT2:** Pipe support foundations that have moved or otherwise settled as a result of erosion either should be restored to their design condition, or the existing pipe saddles should be modified in a manner to re-establish support for the pipes. Eroded areas around the pipe supports and pipe trenches should be backfilled with compacted fill, and the ground surface in the general area downslope from the pipe trenches should be stabilized. To alleviate the condition responsible for the erosive concentrated flow, diversion ditches should be installed just inside and along the north edge of the embankment (above the revetment) to collect local runoff and redirect it towards the lower areas within the BA Pond.
