**SANTEE COOPER
CROSS GENERATING STATION**

Bottom Ash Pond Initial Structural Stability Assessment

Document: CROSS-0-LI-044-0009

Date: 3 Nov 2016

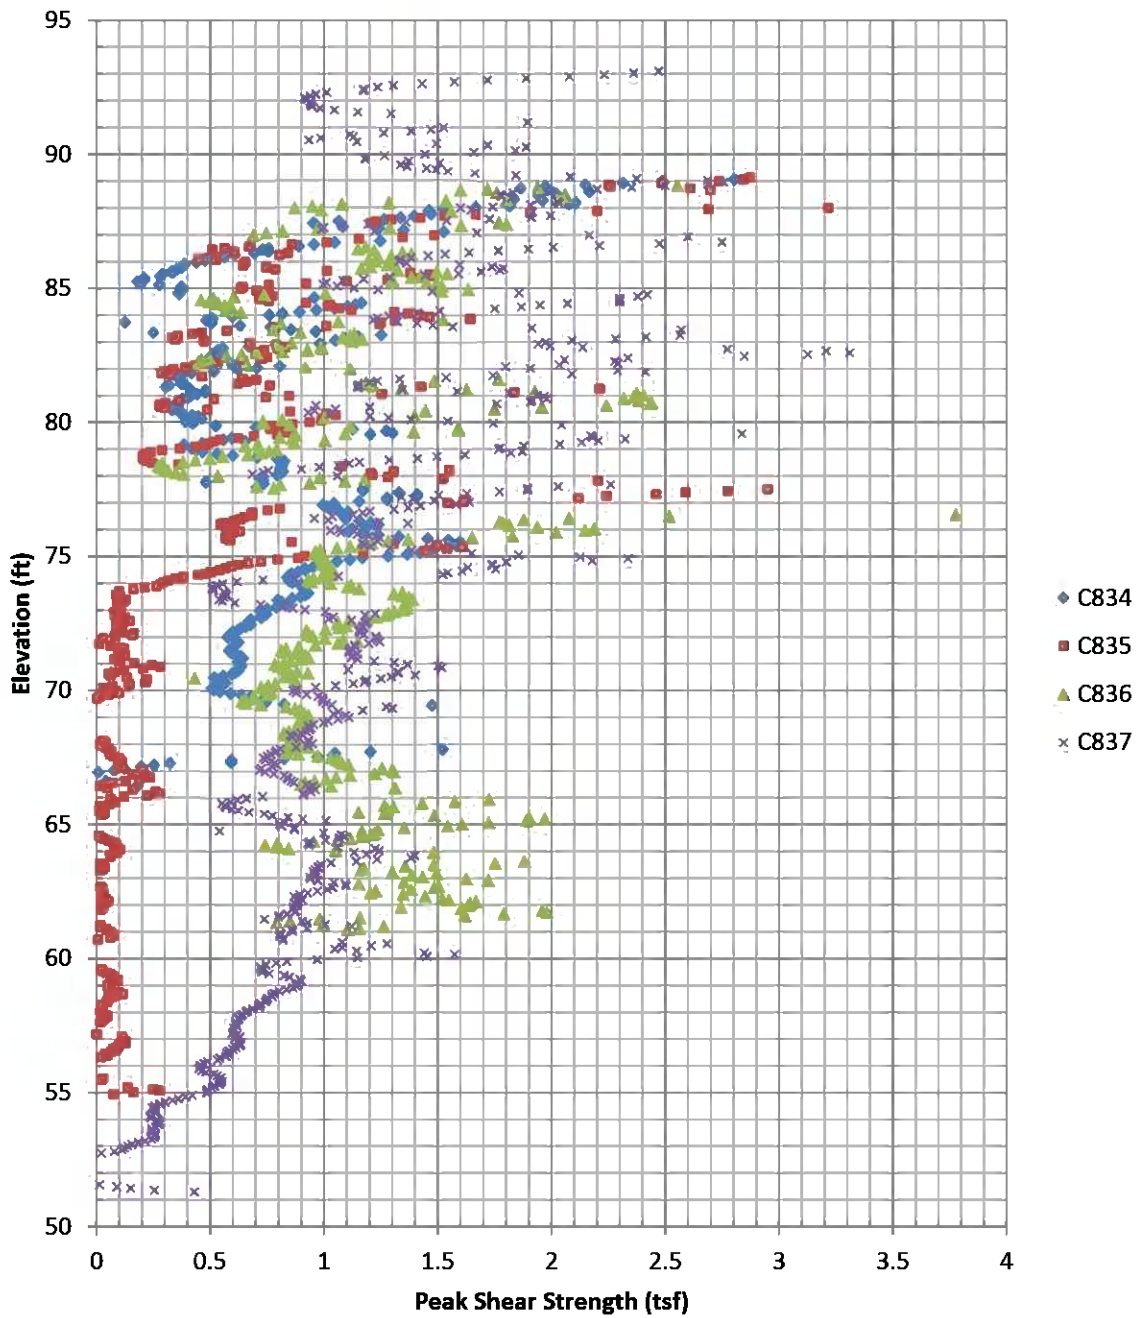
Figure 1

As shown in Figure 1, one of the four CPT soundings performed by Terracon in 2015 shows much lower peak shear strengths compared to the other three soundings. These soundings were advanced through the embankment of the Bottom Ash Pond. While the plot shows more scatter in the data between the elevations of 80 and 75 feet, peak undrained shear strengths are generally less than 2.0 tsf, and average

around 1.0 tsf. However, at the location of sounding C-835, the soils encountered had peak shear strengths generally less than 0.1 tsf below an elevation of 74 feet.

The above worst-case soil conditions were modelled in the Initial Safety Factor Assessment [Ref. 4]. The assessment demonstrated that both static and seismic factors of safety exceeded the minimum requirements set forth in §257.73(e). Although some localized soil zones have the potential to exhibit a reduced strength during a seismic event, they are not considered liquefiable in the classic sense. Also, these zones are not laterally continuous, so widespread loss of strength is unlikely.
