**2026 PERIODIC STRUCTURAL STABILITY  
ASSESSMENT  
SLURRY POND 3 AND 4  
WINYAH GENERATING STATION  
Georgetown, South Carolina**

Project No. 26009458

September 2026

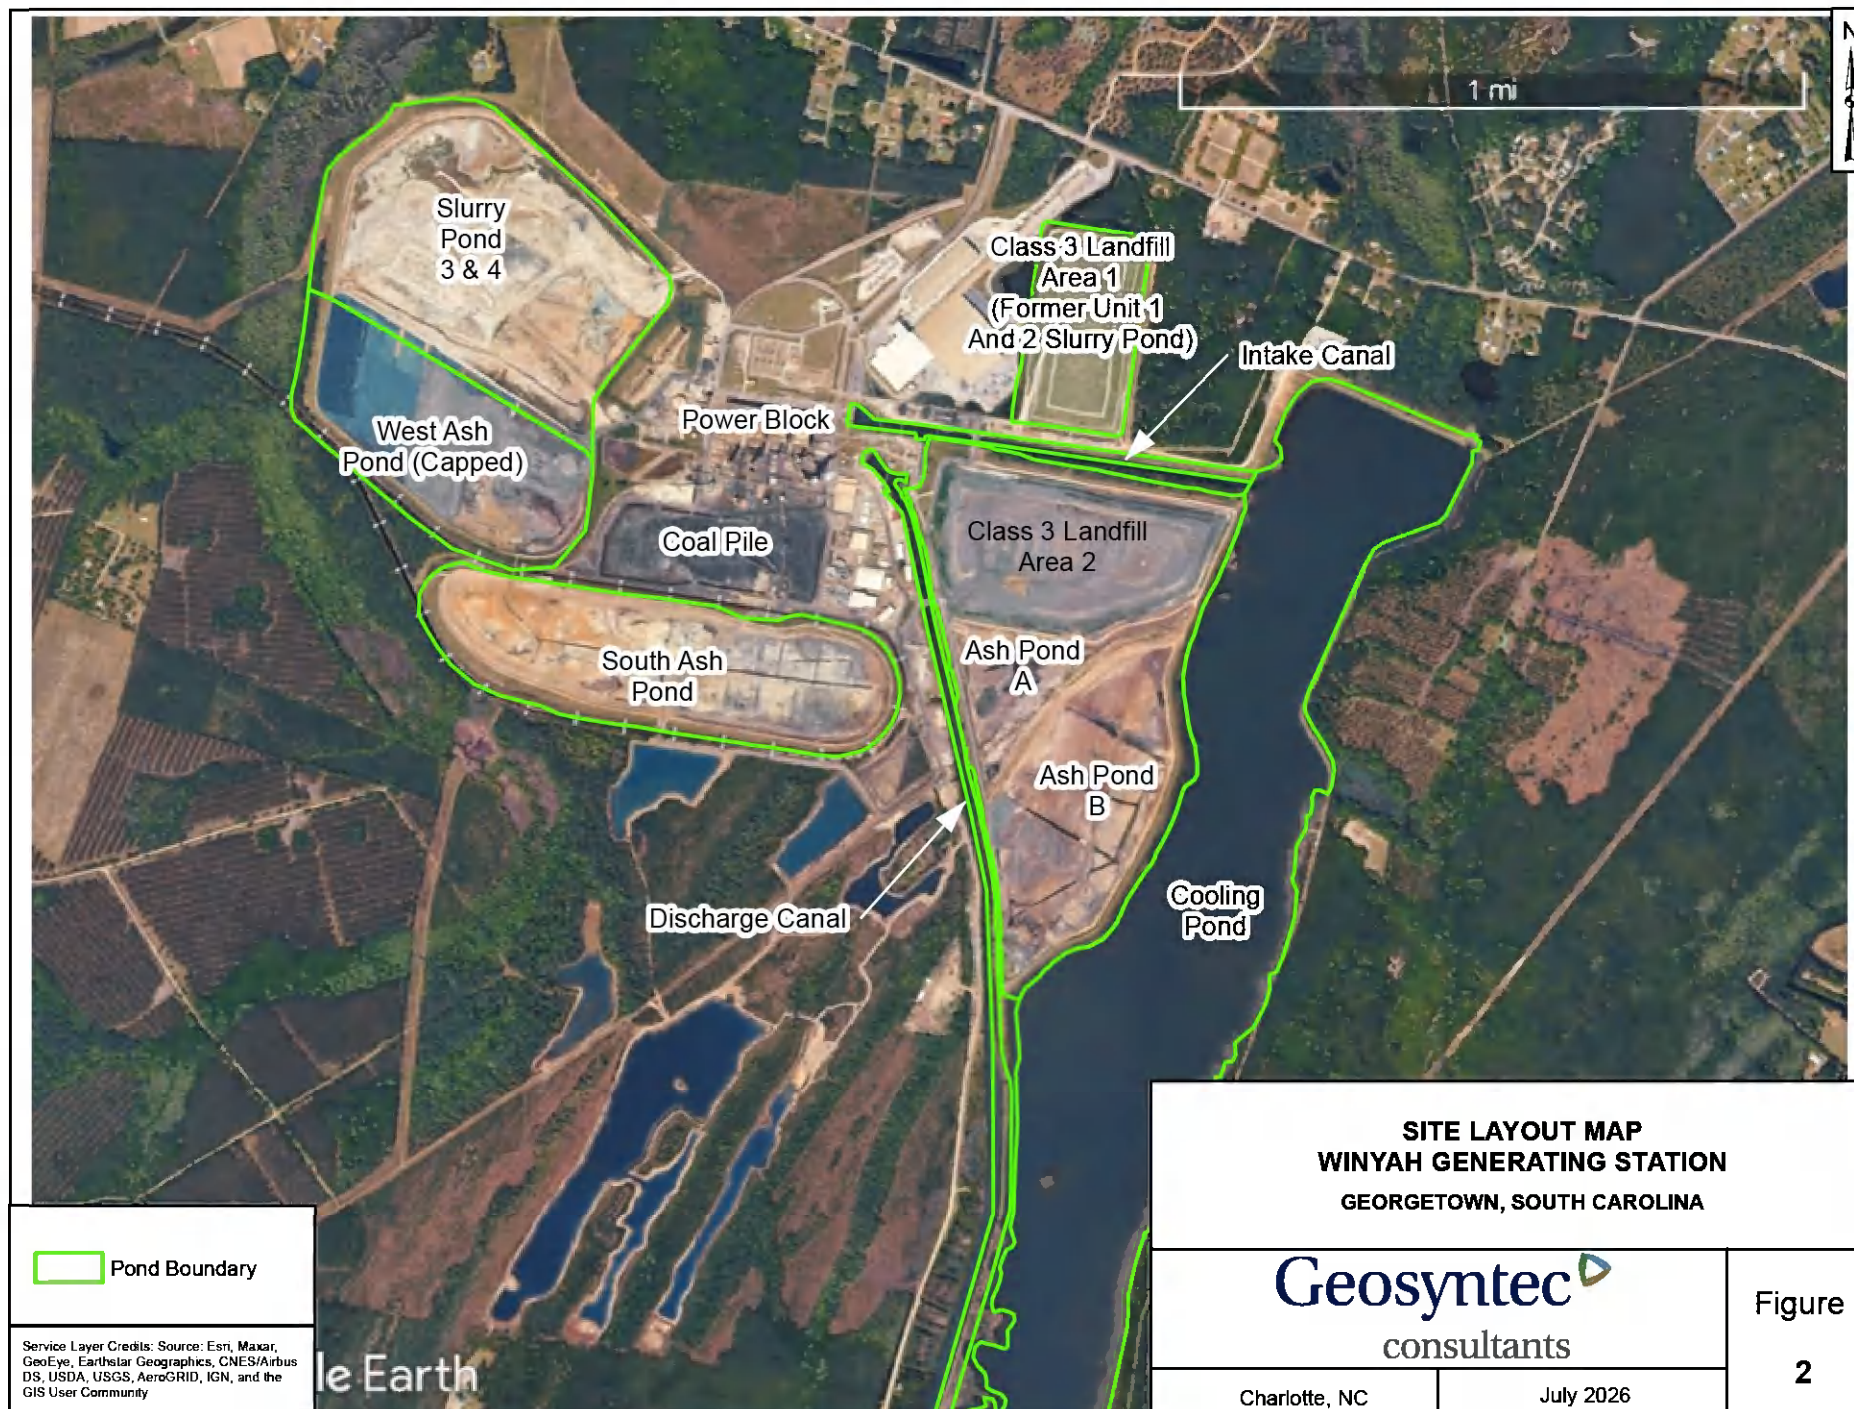
| Figure 2 | Site Layout Map |

The Slurry Pond 3&4 (Slurry Pond) is situated west of the power block (Figure 2). The Slurry Pond contains CCR in the form of flue gas desulfurization (FGD) residuals as well as stormwater. It is considered as an existing surface impoundment under the CCR Rule.
